Weekly Construction Progress Report

Client:	The Nature Conservancy
Project Name:	Wannemacher Nature Reserve
Project Location:	Miami County, Ohio
Date:	WE 10/13/2023

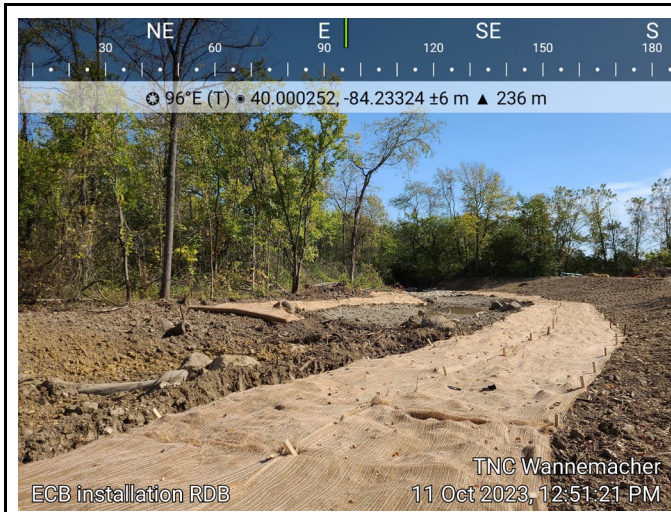
Photograph 1: Seeding and ECB installation downstream of Sta 19+00.

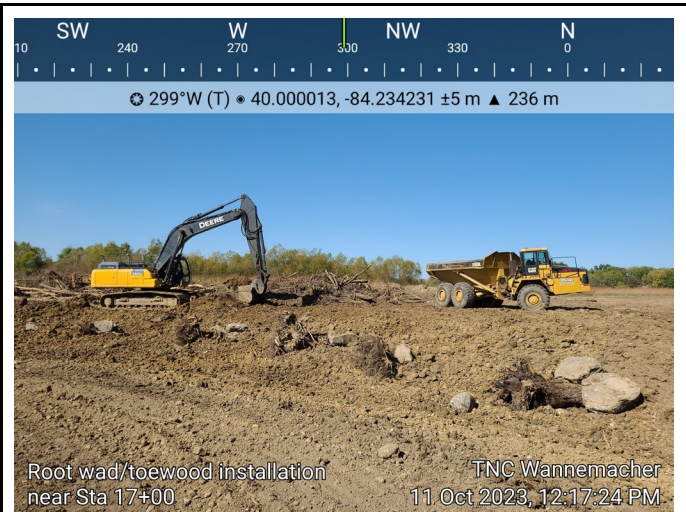
Photograph 2: Installation of root wads and toewood along the LDB near Sta 17+00.

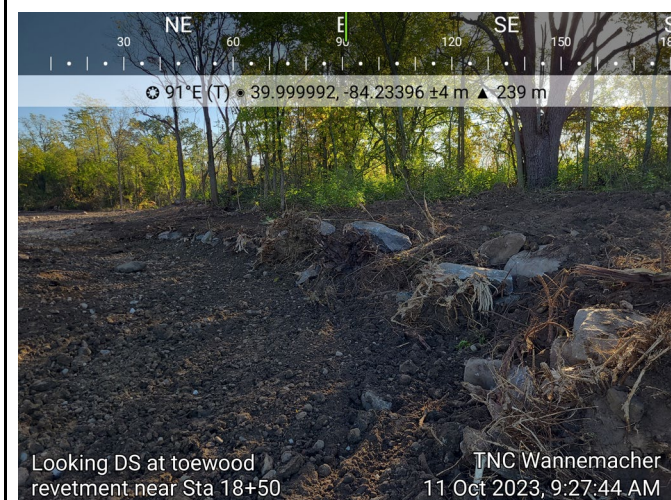
Photograph 3: Rock toe with branch packing and root wads along the RDB at Sta 18+50.

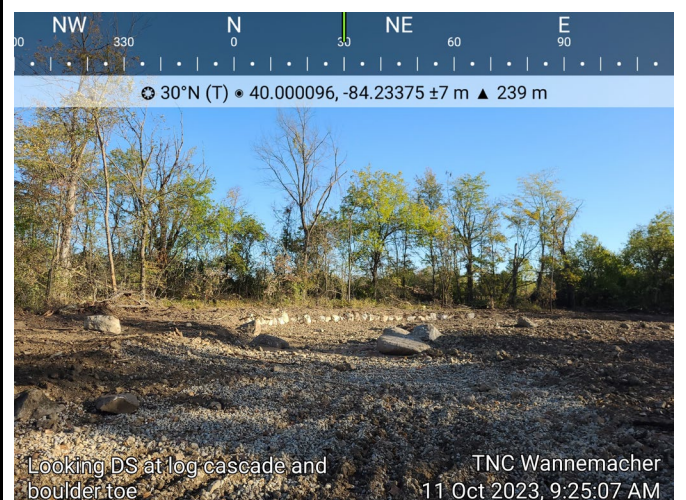
Photograph 4: Looking downstream at amended channel substrate w/ imported #3 and 4 stone.
